INSPECTION REPORT

Government of South Australia

Department of the Premier
and Cabinet

Holder:	Hillgrove Copper Pty Ltd	Date of Inspection:	18/05/2017
Operator:	Hillgrove Copper Pty Ltd	Tenements:	ML 6345, ML 6436
PEPR:	MPEPR2016/010	Inspection Officer:	Alistair Walsh Paul De Ionno
Bond:	\$9,180,000.00	Risk rating:	High
Purpose:	Compliance Audit Inspection

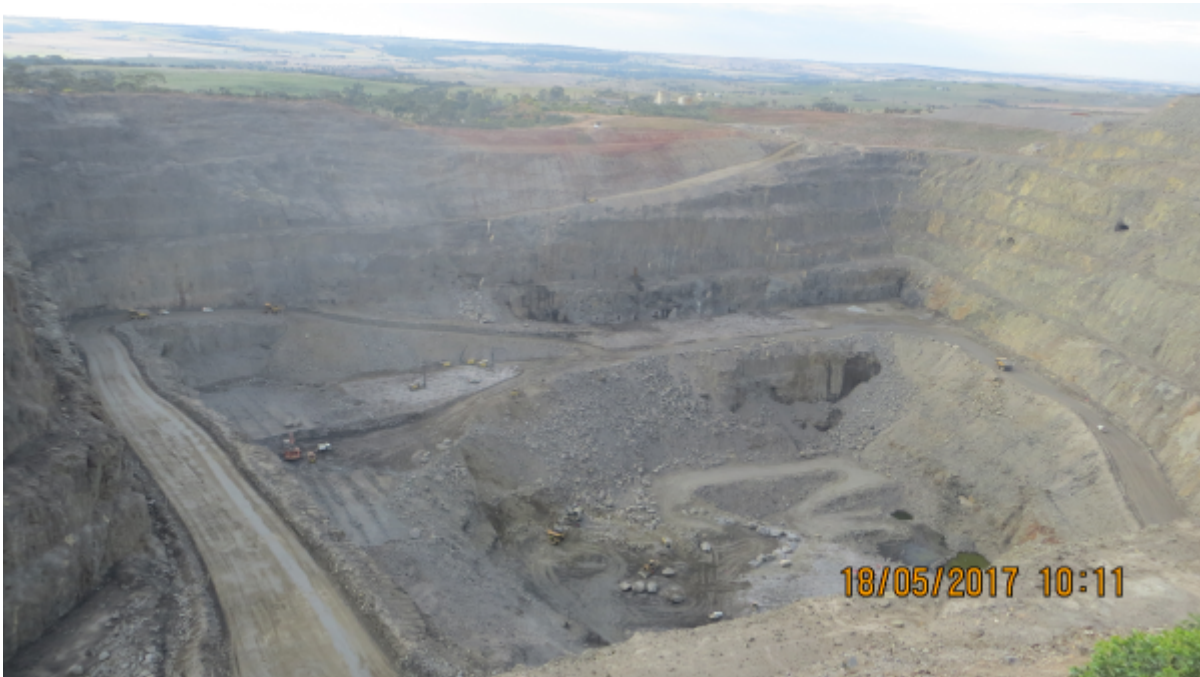
Orientation Looking East South East

Comments View of Giant Pit where a general overview of mining operations was provided to State and Commonwealth Regulators

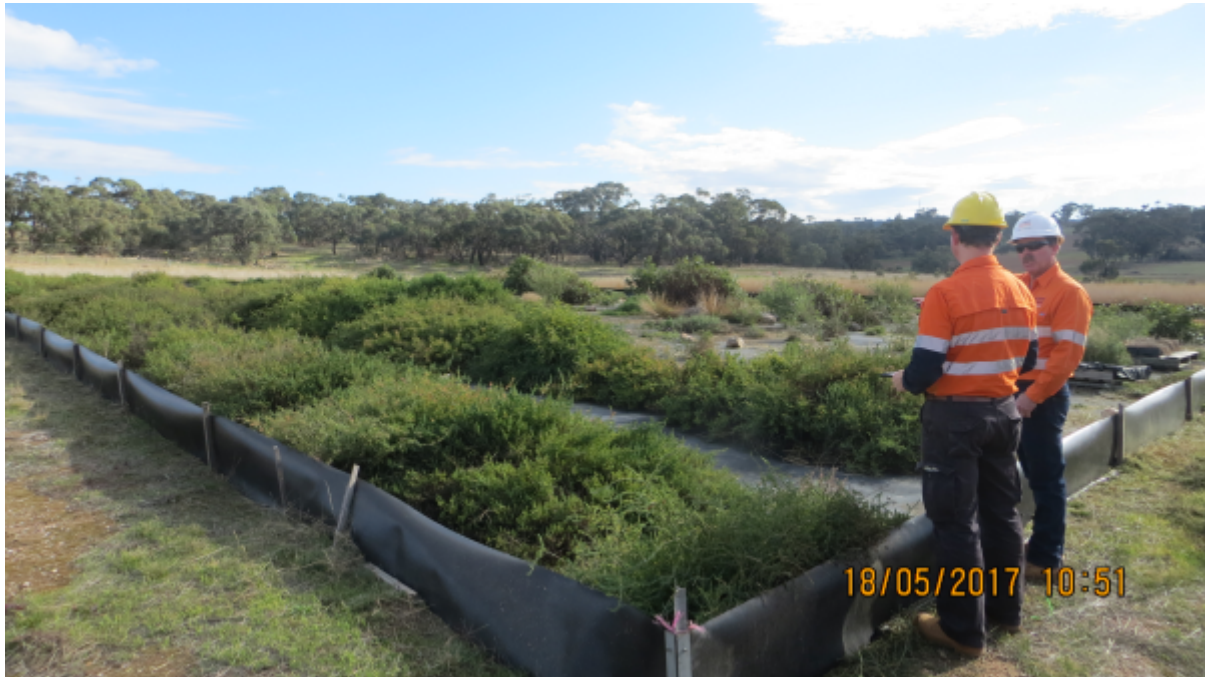
Orientation Looking North West

Comments Hillgrove have established and provide ongoing management and maintenance of a 1ha intensively managed seed production area (SPA) to produce viable quantities of local provenance native seed for use in offset planting areas

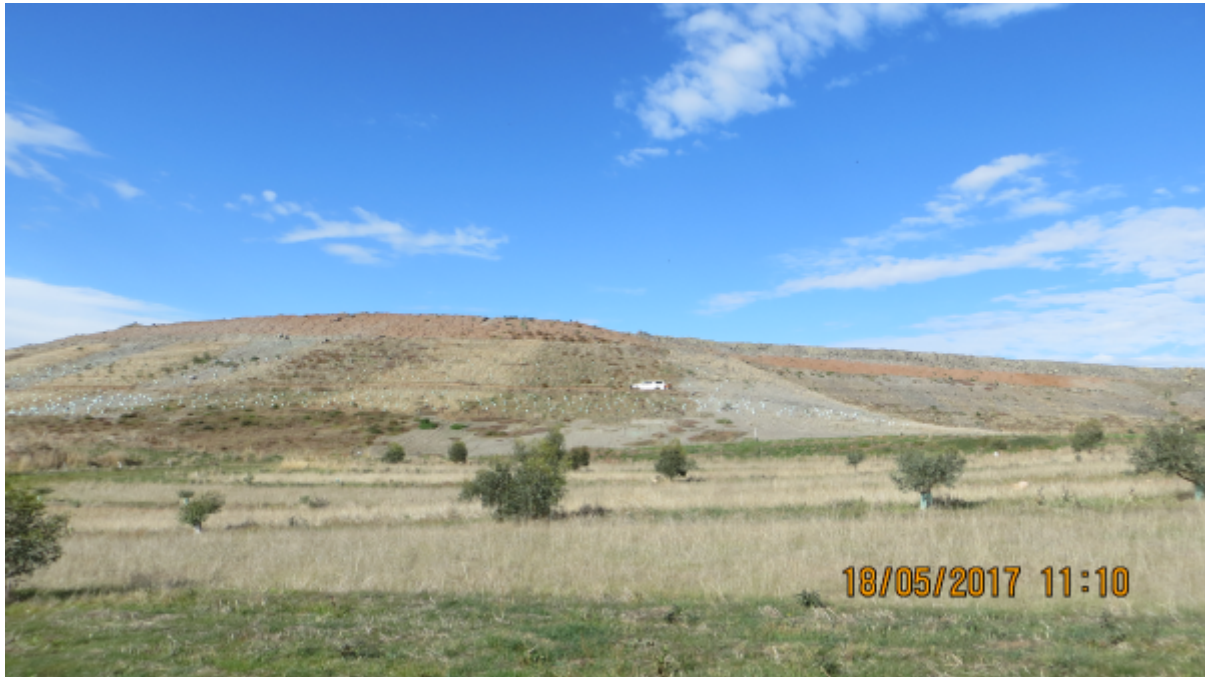
Orientation Looking South

Comments View of rehabilitated slopes on the northern side of the Integrated Waste Landform (IWL). Note EBS (white light-vehicle) were on-site undertaking weed spraying

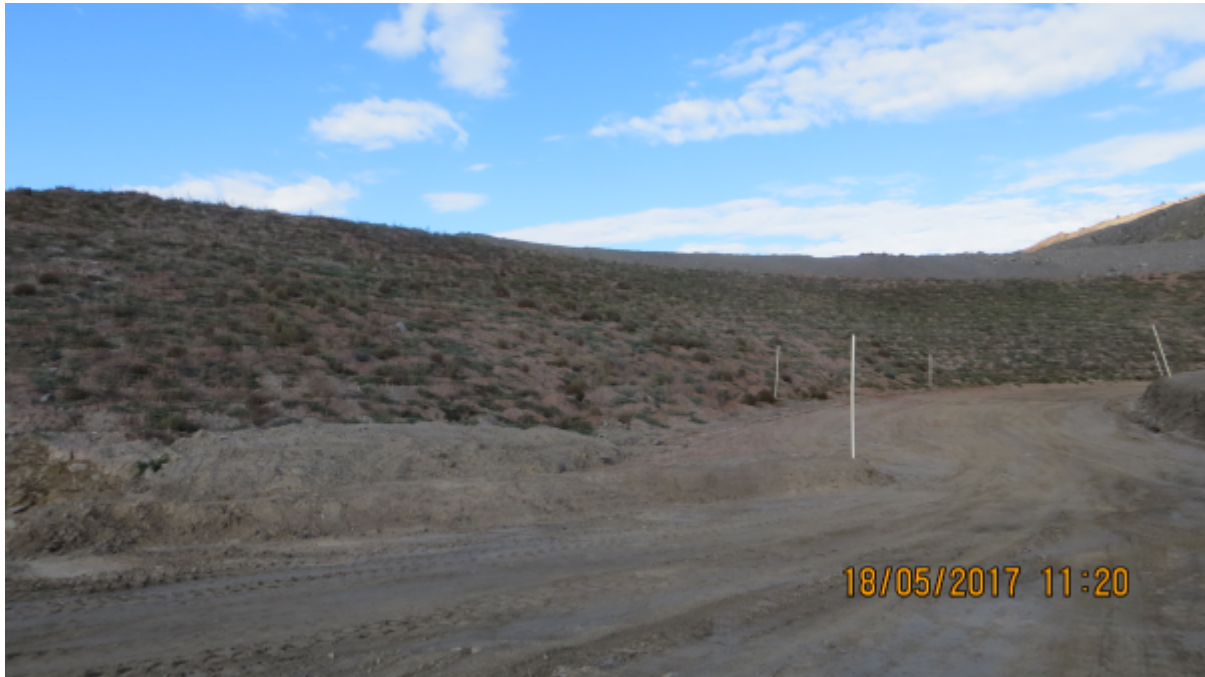
Orientation Looking South

Comments View of backfilled Nugent Pit with the lower slopes rehabilitated.

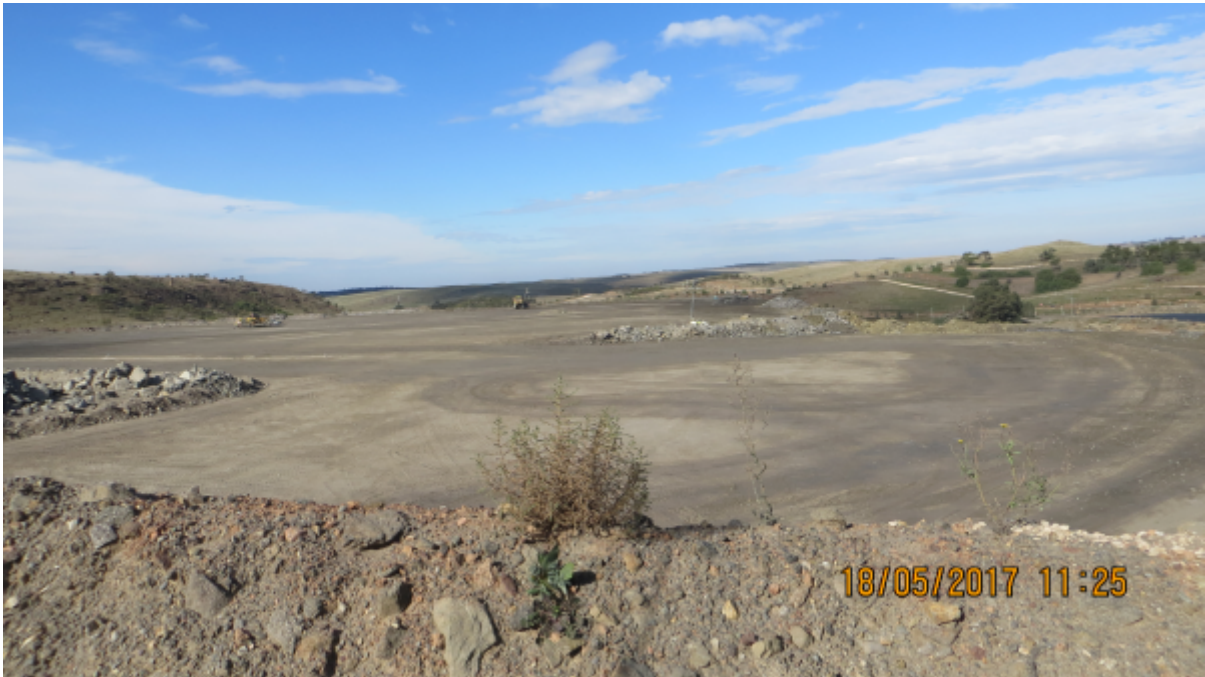
Orientation Looking South

Comments View of backfilled Emily Star Satellite Pit.

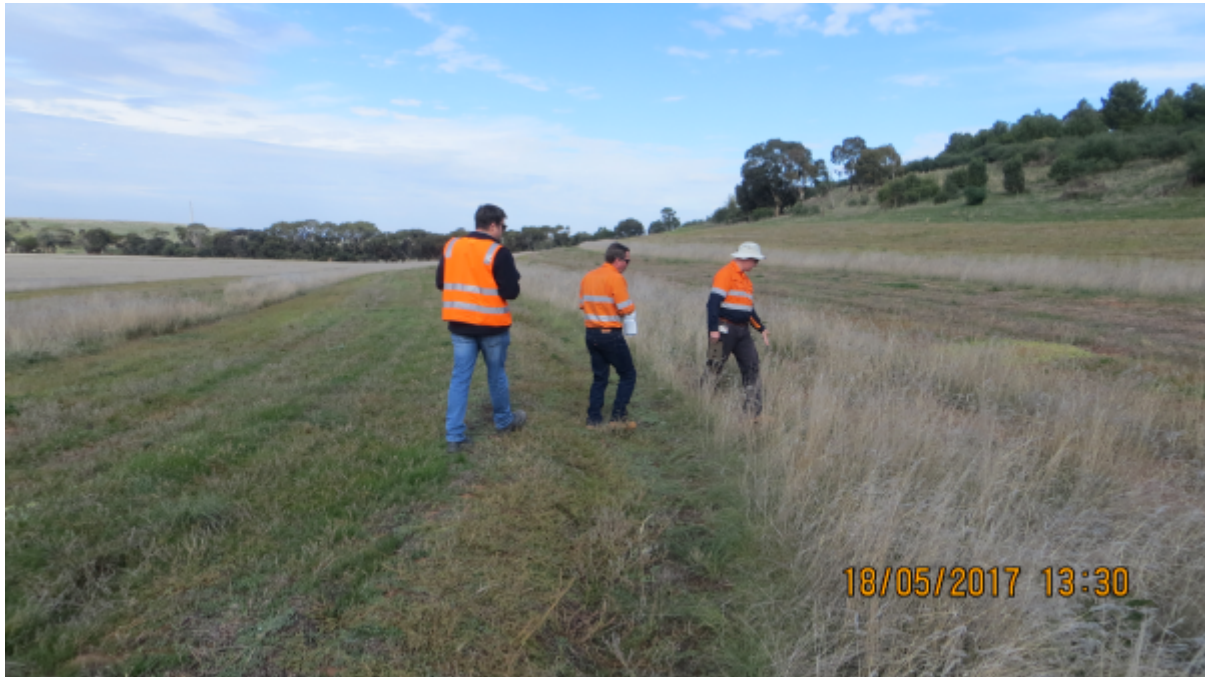
Orientation Looking South South East

Comments View of quarantined land allocated for SEB-offsets where Hillgrove are progressively removing agricultural activity and replacing to native vegetation (grassy strips)

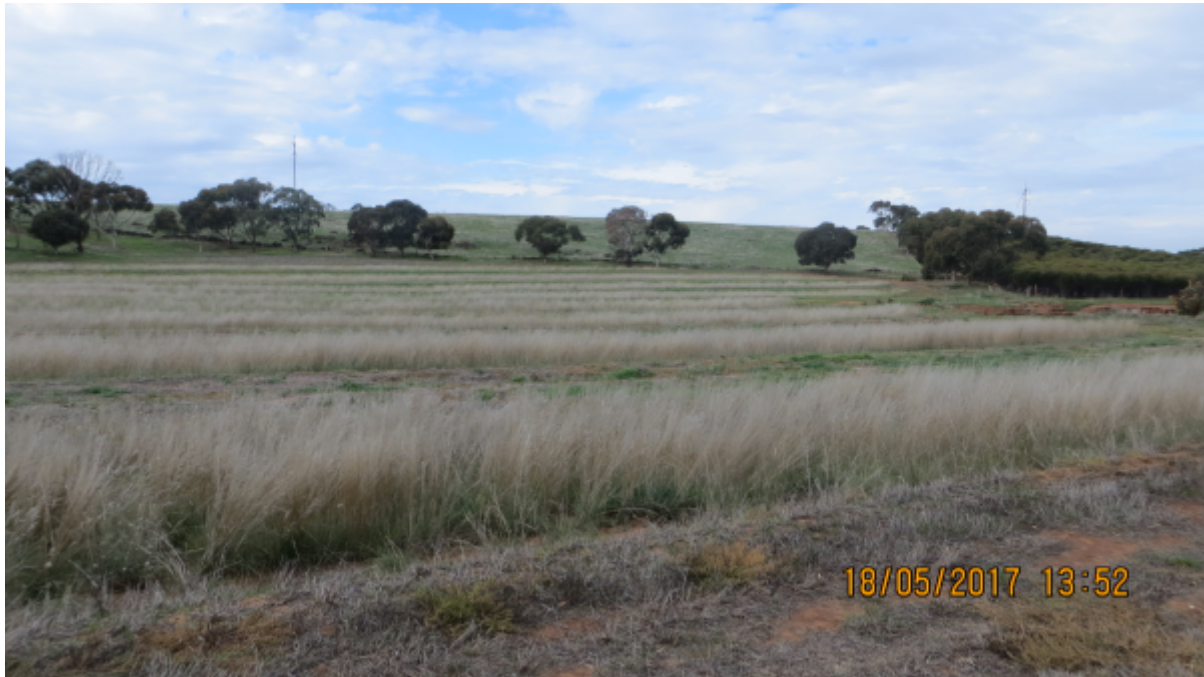
Orientation Looking East South East

Comments View of offset area plantings on Hillgrove owned land adjacent ML 6345 as part of EPBC Condition 3 – Implementation of the NVMP.
